**Brief Observations  
On the Condition and Probable Uses**

**GUANA ISLAND SUGAR FACTORY  
BRITISH VIRGIN ISLANDS**

August 1995

Frederik C. Gjessing  
Post Office Box 301844  
St. Thomas, U.S.V.I. 00803

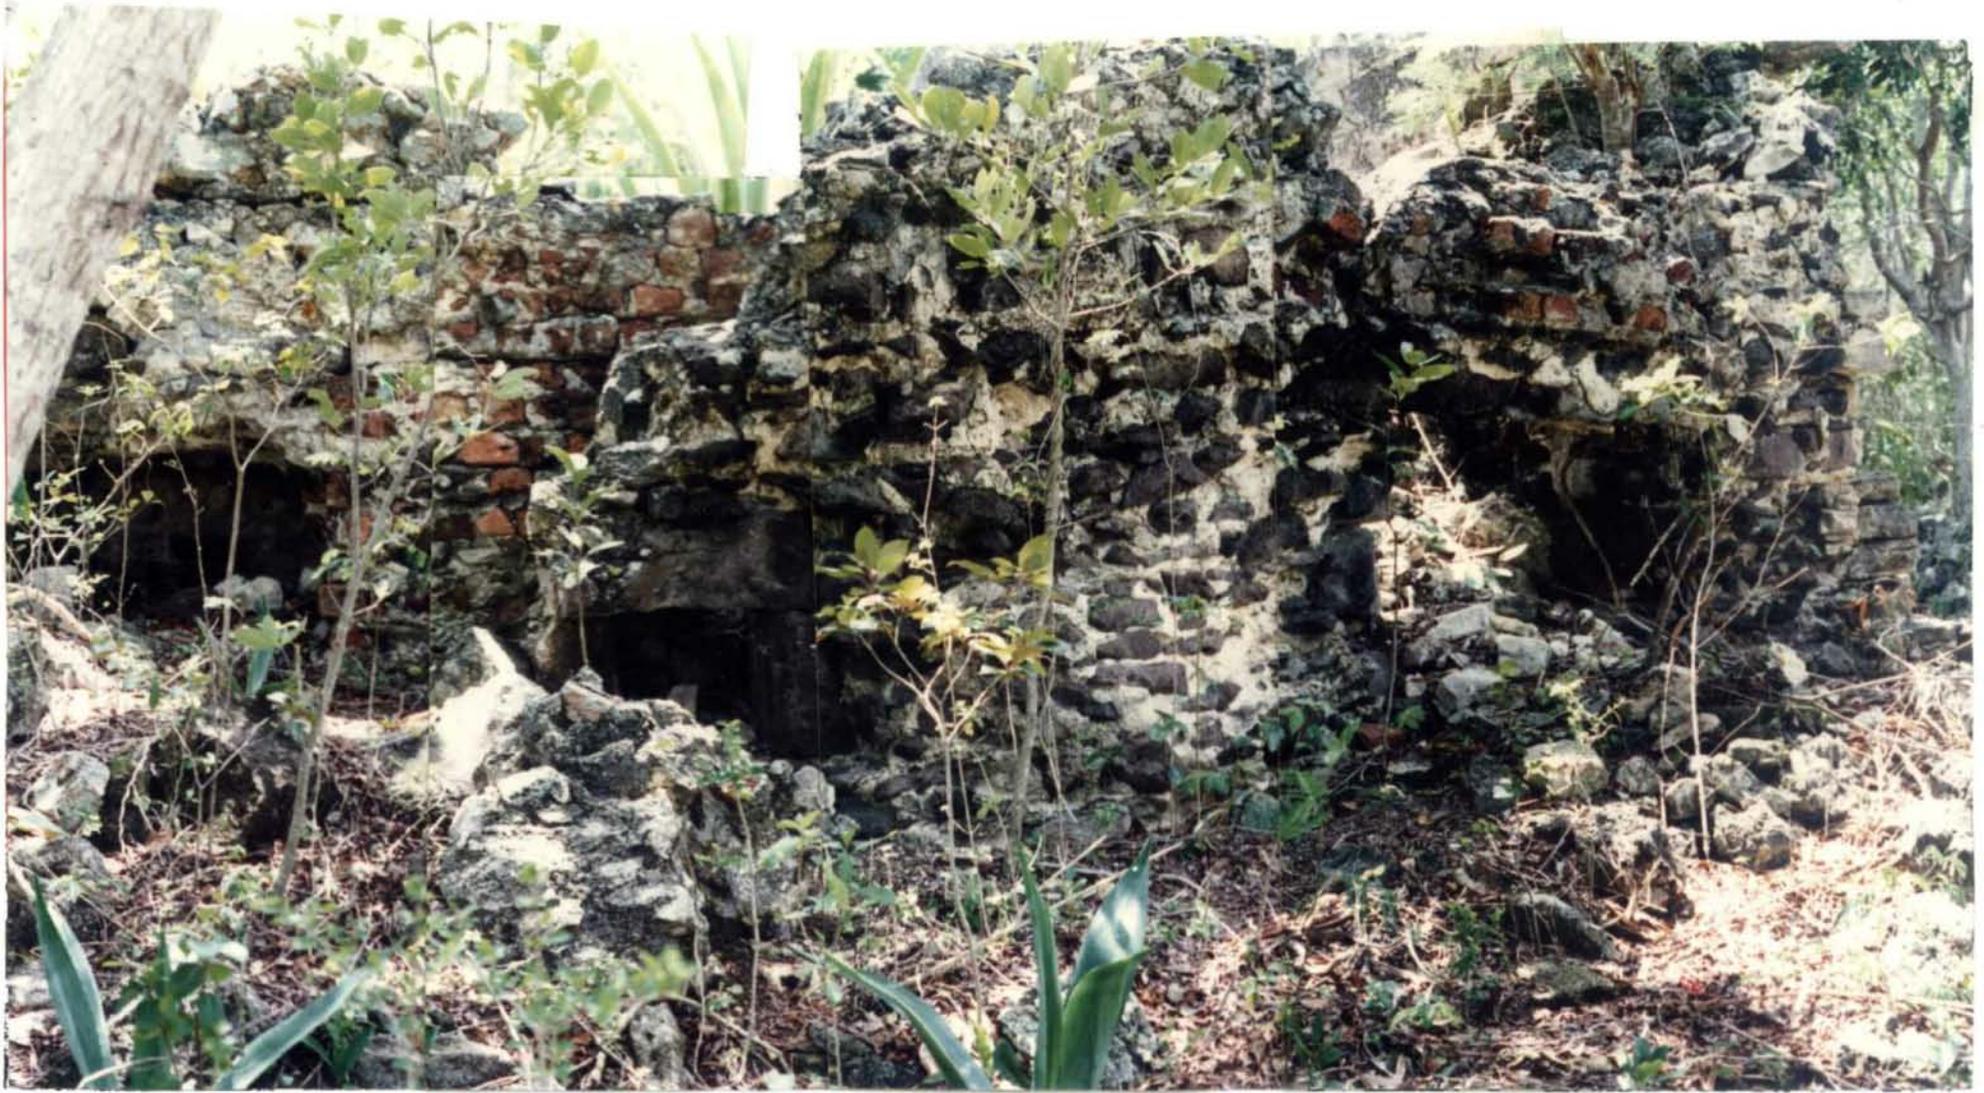
1. All exterior walls against the boiling bench have an interior continuous lining of brick half a stone wide.
2. The exterior face of the north wall has three discernible openings, two large flanking a smaller one leading in under the boiling bench through the masonry. (See Photo No. 1) The large opening near the west corner has the remains of a finished curved cover approximately two feet above the crown of the opening. It is an indication of the horizontal flue that once connected to a chimney outside the building.

Both the above features are characteristic of a sugar factory where a constant and greater heat is needed than in a rendering plant.

Photo No. 1: Exterior face of north wall with firing gate at left, the vent for draft control in center and the exit of the horizontal flue to the right. Note its finished cover.

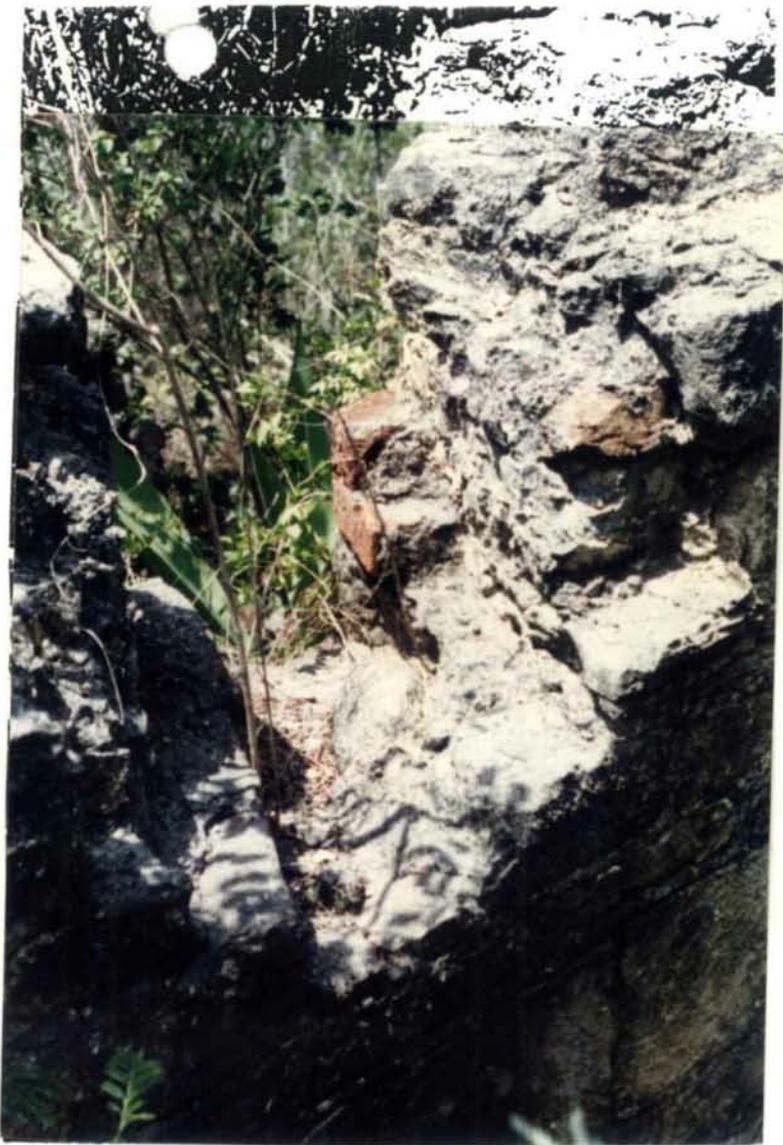
3. There is a built-in slit through the east wall above the boiling bench. It is broad enough to accommodate the wide gutter for the cane juice that once flowed from the cane crusher to the receiving copper of the boiling bench. (See Photo No. 2)
4. The channel for the cane juice gutter led to our discovery of the animal mill round on the east side of the ruin in an area of a dense growth of bush. Only badly deteriorated fragments of its former retaining wall indicate its limits, but enough has been preserved to provide a fairly accurate estimate of its diameter. (See Photo No. 3)

Photo No. 2: Apperture for  
cane juice gutter  
in east wall.

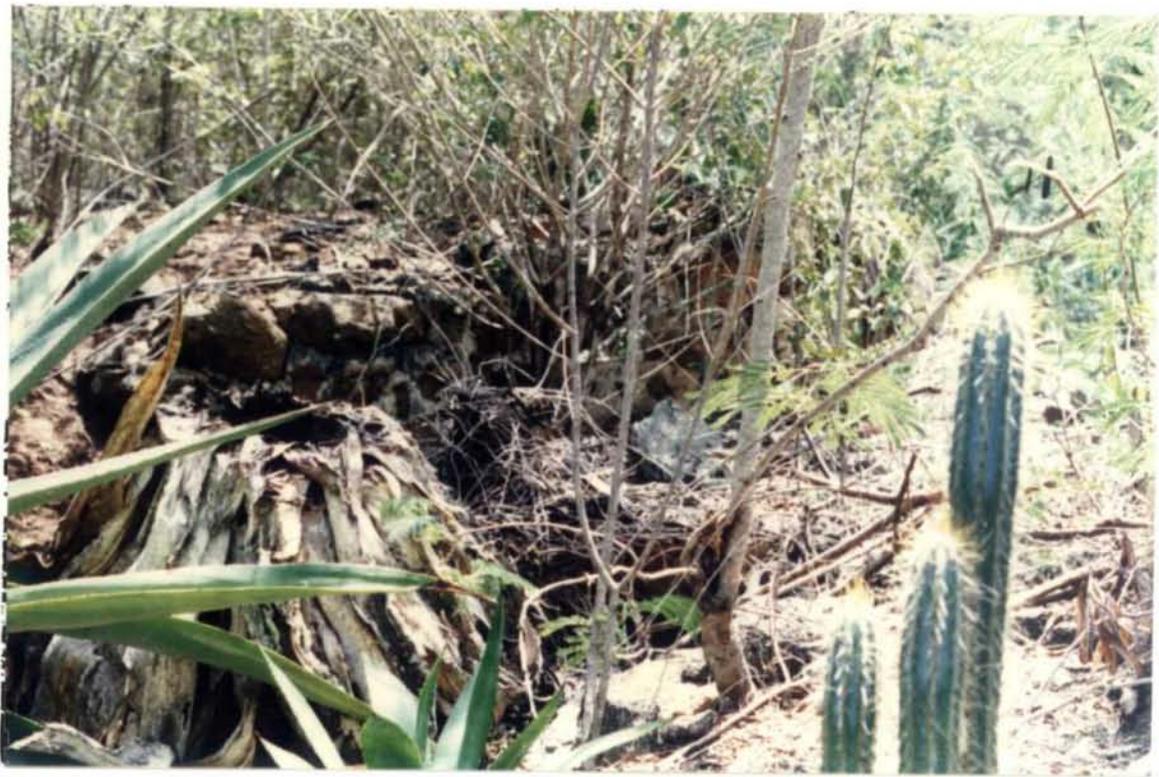
Photo No. 3:

A preserved section of the animal mill round's  
retaining wall.

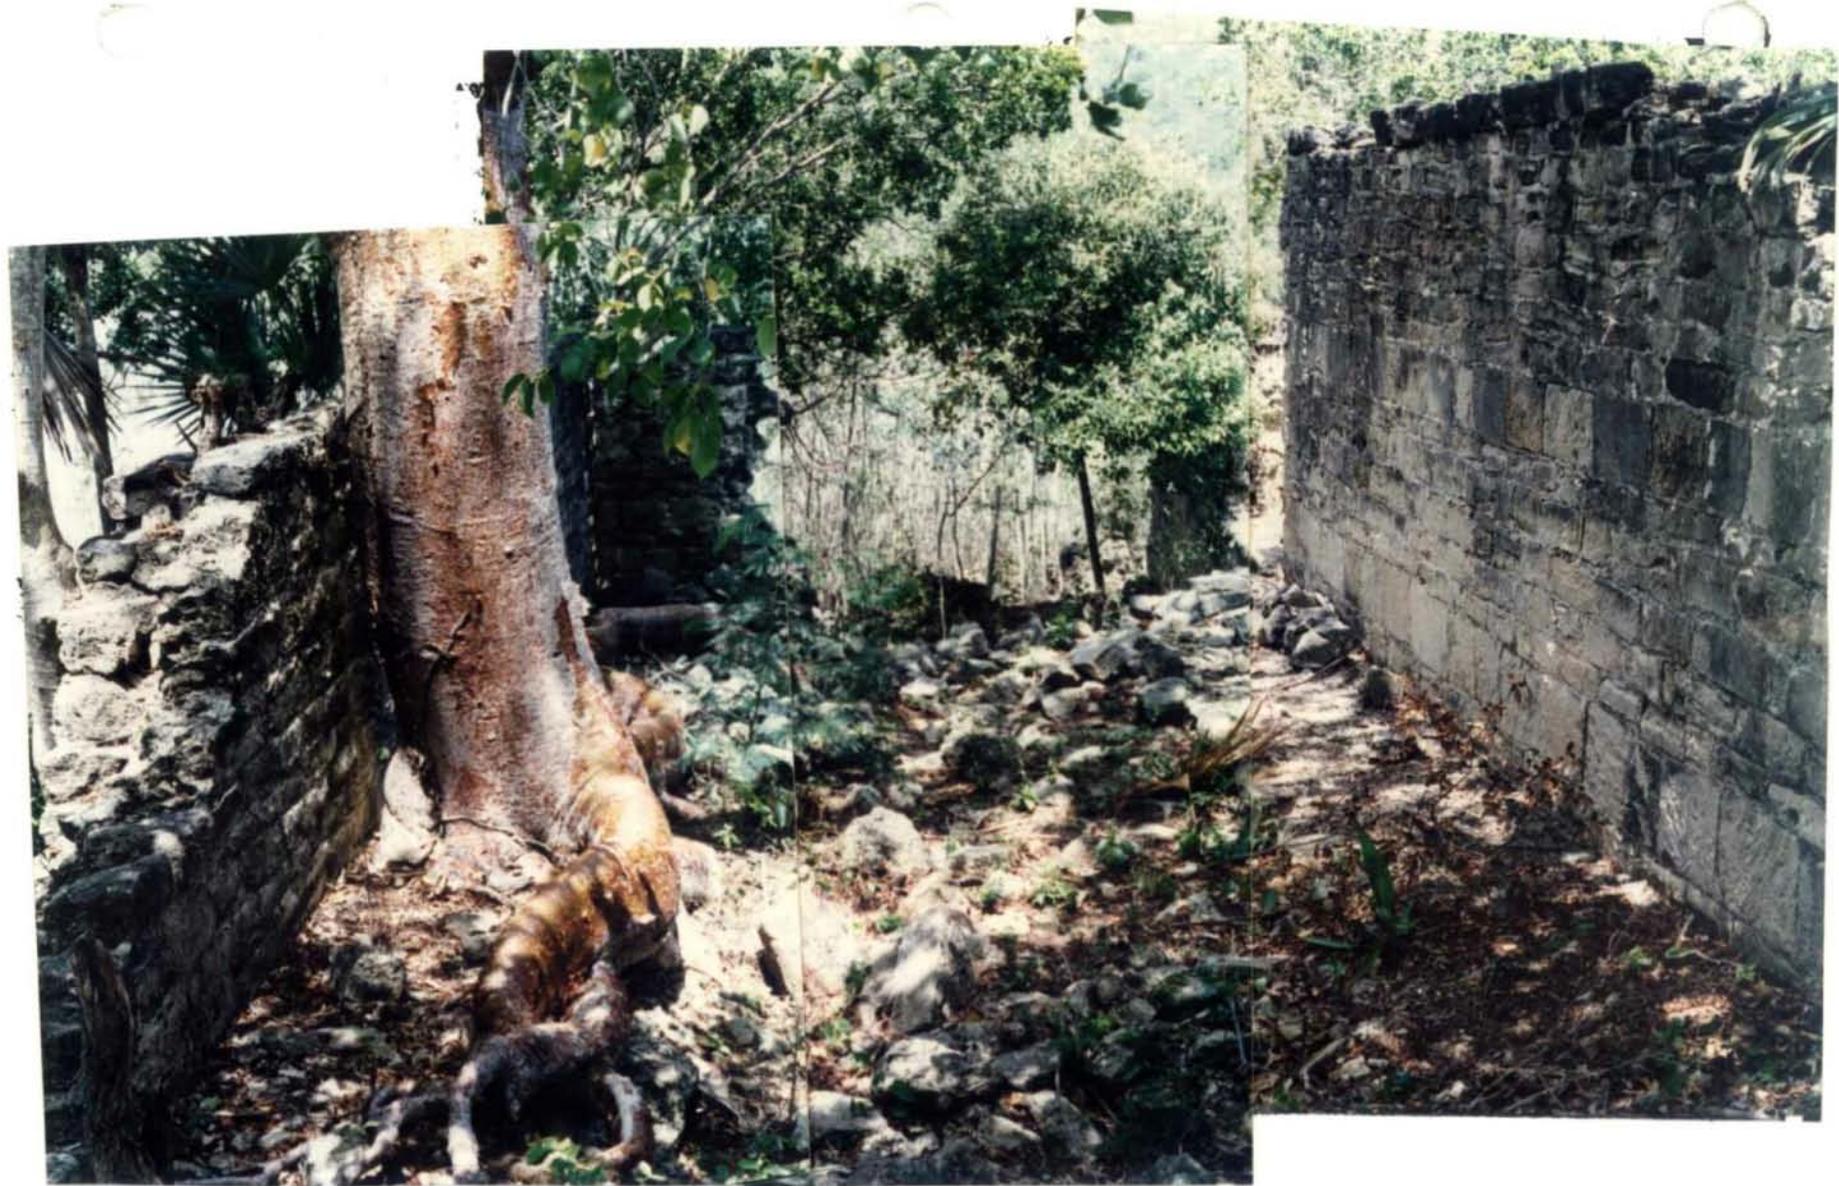
These findings made it easy to identify the former use of the smaller room on the western side of the structure as the "curing house" of the factory. Along both long walls of the room there are remains of a pavement area three feet six inches wide raised above the center area. In its pristine condition the entire floor area would have been finished in a hard plaster with the raised sections sloped toward the center area and the center area sloped to a low pit somewhere within the room. (See Photo No. 4)

Photo No. 4: Interior of curing house looking north.  
The remains of the stepped up pavement can be seen  
against the wall to the right.
